BRITISH RAILWAYS : EASTERN REGION

Ref : R03/GEN.22/26

Date : 29th October 1985

REPORT OF A JOINT INQUIRY HELD AT NEWCASTLE ON FRIDAY, 4 OCTOBER
1985 INTO A COLLISION BETWEEN TRAIN 9T04 AND LIGHT LOCOMOTIVE 37072
AT SIGNAL TY 183 IN TYNE YARD WHICH OCCURRED ON SUNDAY, 29 SEPTEMBER
1985

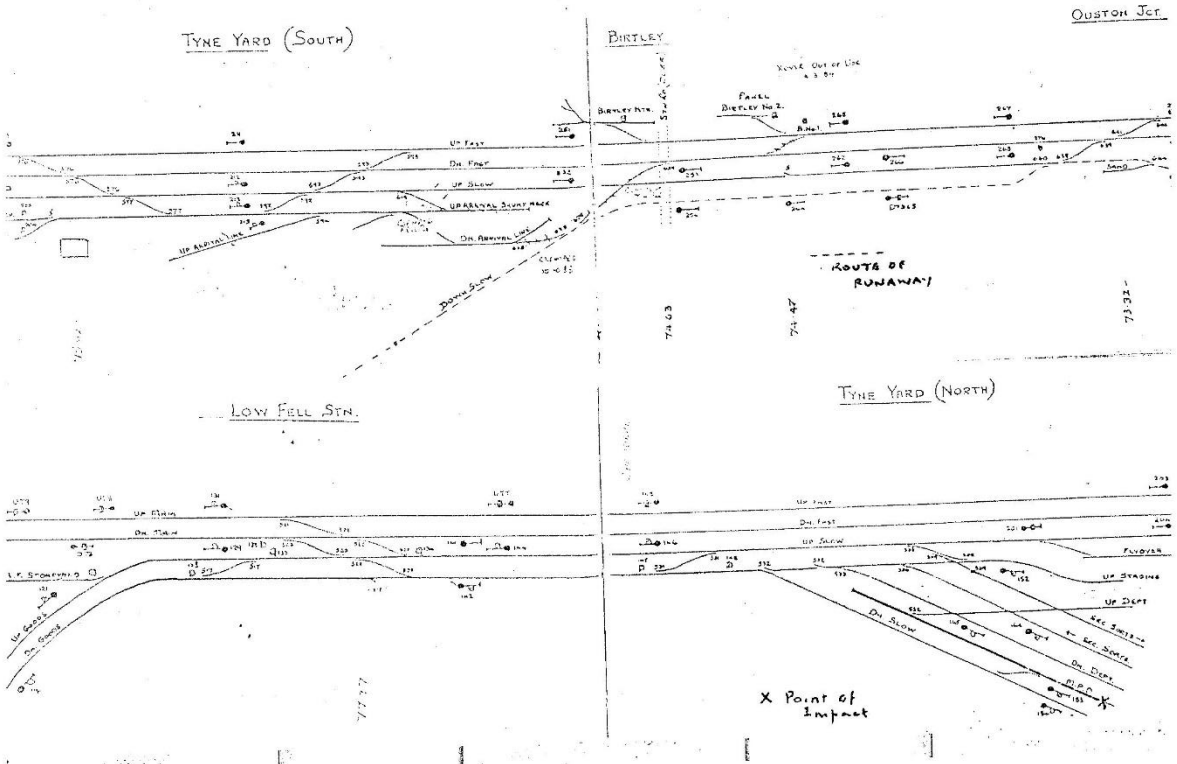
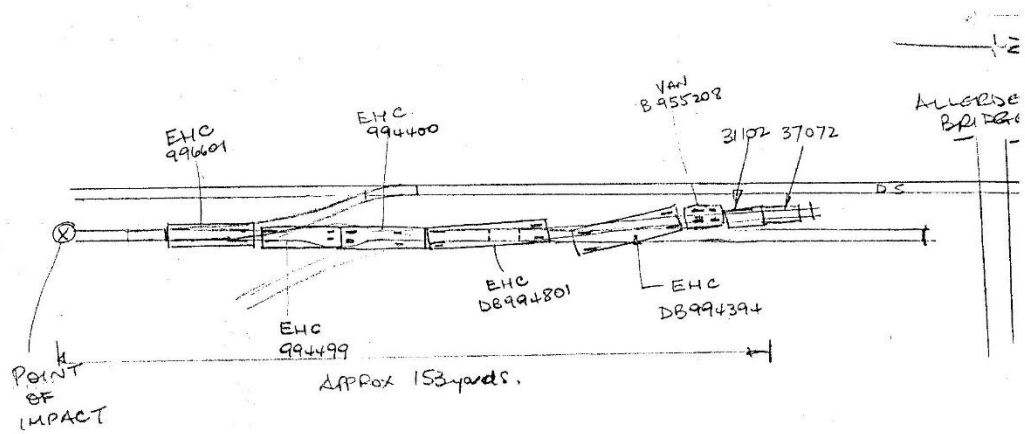
POSITION OF LOCOMOTIVES & VEHICLES FOLLOWING COLLISION.

After the collision, Locomotive 37072 was pushed approximately 150 yards. Both locomotives 37072 and 31102 remained on the track but were severely damaged. The brake van and all the 5 HC wagons were derailed in the Shunting Neck of the Engine line.

On arrival at Tyne Yard at approximately 1420 hours I found that 9T04 had collided with loco 37 072 at TY 183 Signal and pushed the loco approximately 150 yards. Both loco 37072 and loco 31102 off 9T014 were still on the tracks but a brake van and 5 wagons had become derailed due to the collision.
